The procedure described in this document typically improves DTMF (Touch-Tone) detection in the RFC-1/B. It applies to systems that work normally when accessed from the "local phone" that is connected directly to the system but work intermittently or fail when dialing in from a remote location.

### Modification Part I

## **Modification Part 2**

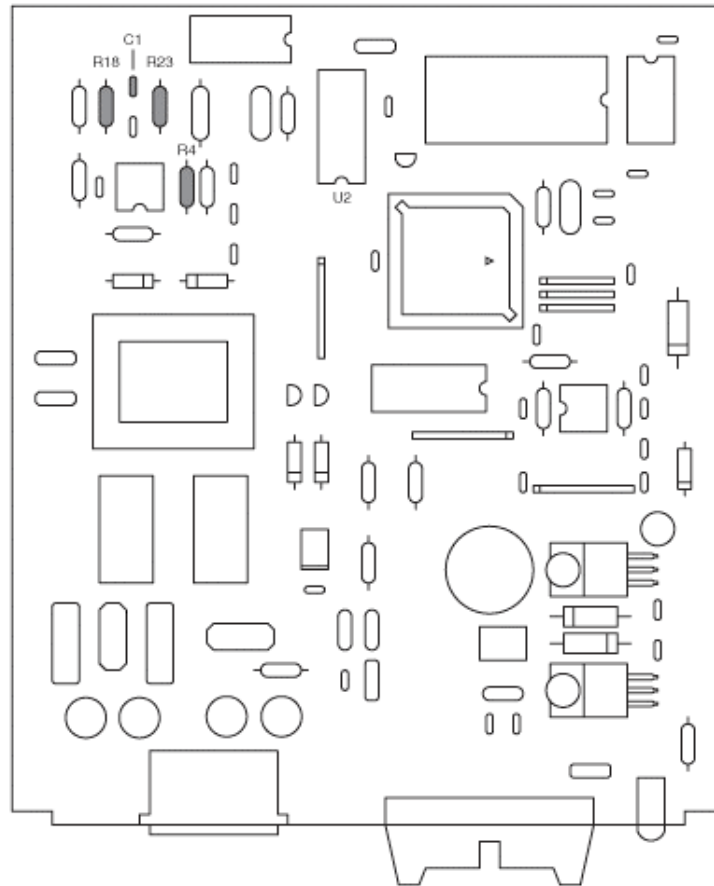
*Location of R23*

The IC at location U2 must be labeled CD22202/CD22204 or 75T202/75T203. If it is not then do not continue with this procedure. There is another modification that may help.

Resistor R23 should be located near the upper left corner of the RFC-1 circuit board. It is shaded in the image below. If R23 is not in the same location as shown in this image then this modification is not appropriate for your system.

This modification involves R18 in addition to R23. R18 is located to the left of R23 across the two small capacitors. As before, if the location of the parts does not match the drawings then do not continue with this procedure.

If the system works from the local phone but does not work when dialed in, there is another modification. Locate a very small capacitor C1 between R23 and R18 in the drawing above. If it exists in the same location on your board, carefully remove it from the circuit.

The modification is a resistor substitution that involves only R23. Most RFC-1/B systems have a 270K ohm resistor at position R23. Replace this resistor with a 100K ohm, 5-10% tolerance, 1/4 watt resistor.

If the modification fails to solve the problem then substitute a smaller value resistor, about 47K ohms. If that does not work, try 10K ohms.

Remove both R23 and R18 from the circuit. Do not replace R18 with anything and do not short it. Replace R23 with a low value resistor anywhere from 1K down to 100 ohms. If a suitable resistor is not available R23 can be shorted.

If you are in the field and do not have a low value resistor available, use the resistor removed from R18. At 33K ohms the value is a little high but with R18 removed from the circuit the value of R23 is less critical.

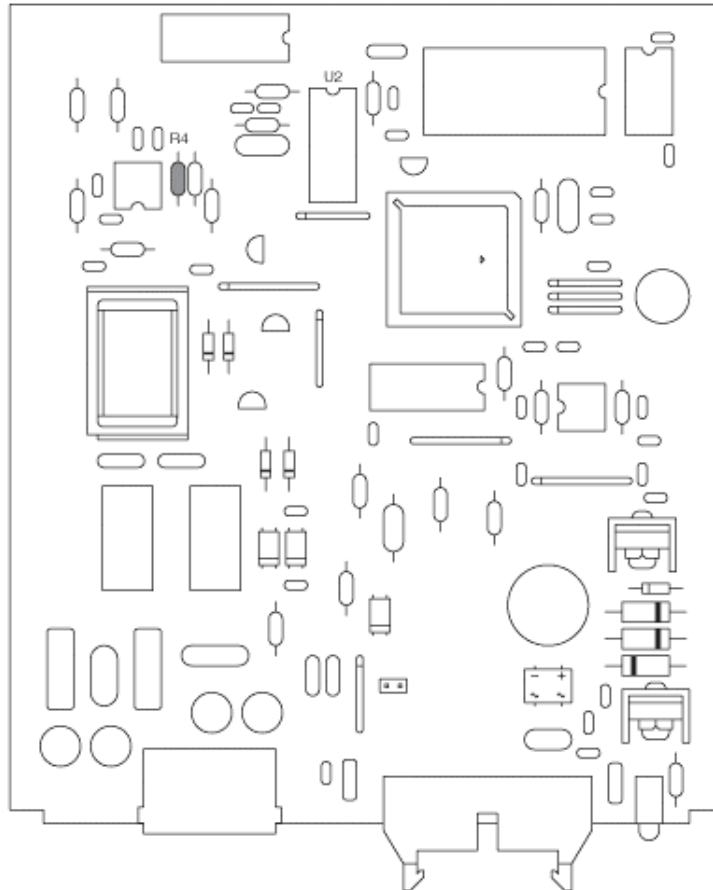
*Location of R4*

Resistor R4 should be located near the upper left corner of the RFC-1 circuit board. It is shaded in the image below. Resistor R4 should be next to the 8-pin IC in all cases. If it is not, do not make any changes.

It is important to be conservative when changing the value of resistor R4. This procedure should solve tone detection problems on remote calls but also may potentially cause tone detection problems on the local phone if adjusted too much.

The modification is a resistor substitution that involves only R4. Most RFC-1/B systems have a 20K ohm 1% tolerance resistor at position R4. Replace this resistor with a 27K ohm, 1% tolerance, 1/4 watt resistor.

If the modification fails to solve the problem then substitute a slightly larger value resistor, 33K ohms. If that does not work, try 39K ohms.
